Remote assessment of tsunami damage in Japan by means of Google Street View images

Project Report

Jessica Miles and Alan G. Bloodworth

University of Southampton

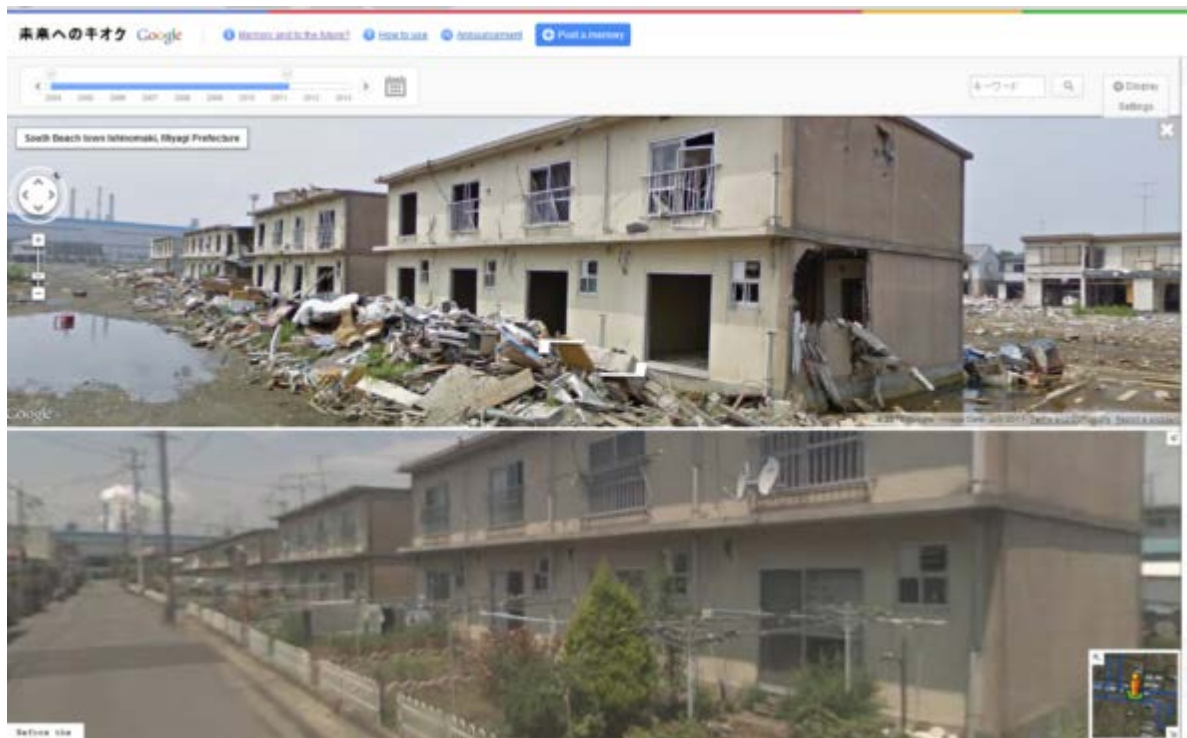
Figure 1 'Before' and 'After' Google Street View image (Google Street View, 2013a)

Structural concrete panel construction. Within the 9% of buildings left standing in Area A was a group of seven two-storey apartment blocks of concrete structural panel type (Fig. 1) (EEFIT (2011) describe similar buildings as ‘RC shear wall construction’). They survived with damage levels D1 to D3 (four of the seven at D1), despite being inundated to roof level and with almost everything else around them washed away. This could potentially be a very important form of construction in coastal communities, if constructed higher than inundation level to improve survivability. Damage was worst at the corners where the waves were funnelled around the buildings. This was also observed in other structures, suggesting buildings should be orientated longest side perpendicular to the shoreline to reduce flow speeds around corners, and corners of buildings designed for greater wave forces.

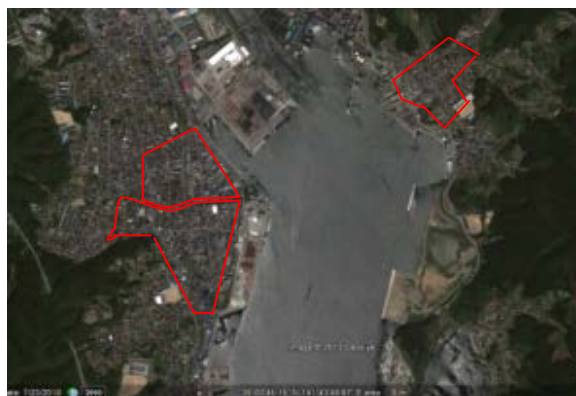
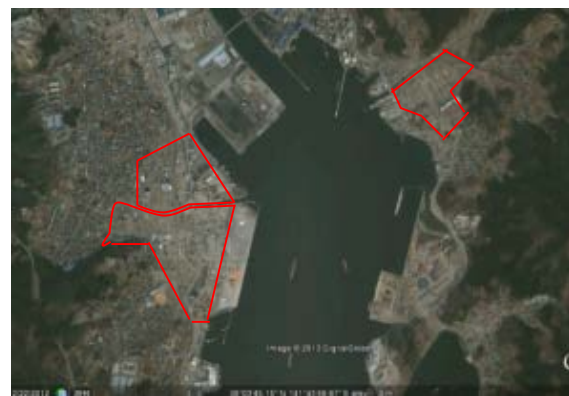
Ofunato is a city on the ria coastline, located in a narrow bay bounded by steep hills. Despite the wave funnelling to an inundation height of 13.13m at the shoreline, the steep rise in topography meant that 69% of housing escaped inundation (EEFIT, 2011). The harbour front is occupied by commercial buildings. Sample zones were chosen either side of the bay (Fig. 3) containing a total of 696 buildings before the tsunami, of which 108 (15.5%) remained standing sufficiently to be surveyed.

Figure 3 Sample zones at Ofunato 'Before' and 'After'- 04/04/10 (Google Earth 7.0, 2010a) (left) and 03/04/12 (Google Earth 7.0, 2012a) (right)

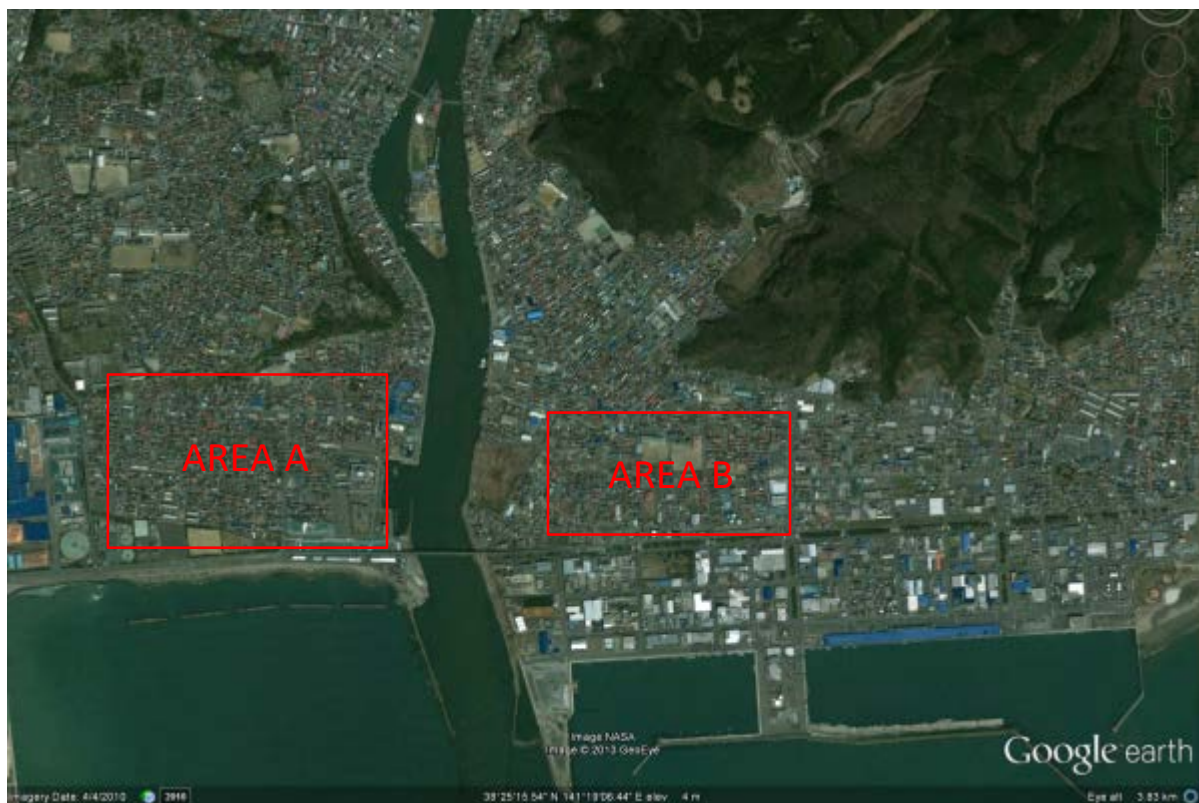
Data were collected in two sample zones either side of the River Kitakami (Fig. 6). 'After' images were taken in July 2011, four months after the event.

Figure 6 Ishinomaki survey sample zones, 'Before' – 04/04/2010 (Google Earth, 7.0, 2010b)
